7FH Generator Slip Ring Incident & Effective Maintenance

Jafar Ali Al-Holaimi

Qurrayah Combined Cycle Power Plant

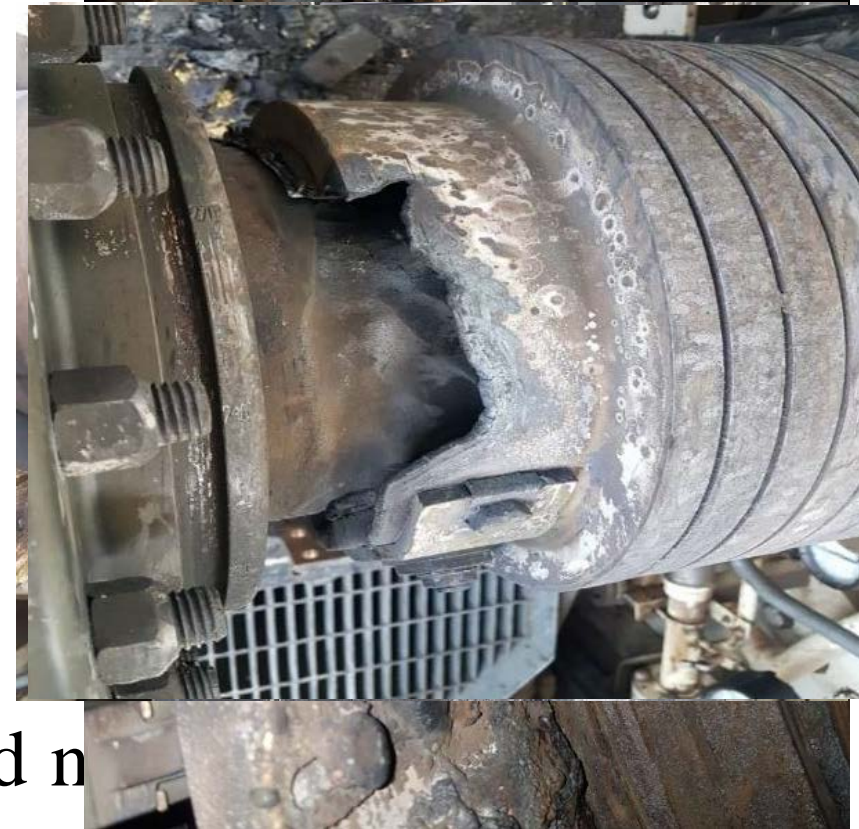
- ❑ After Unit Trip, site investigation conducted.
- ❑ Considerable damages observed in the following parts
 - Carbon Brushes
 - Brush holders
 - Brush holders assembly
 - Slip ring surface
 - Rotor Shaft
- ❑ Turning Gear fail to engage and n after shutdown.

- ❑ Immediate assessment done and decided for generator rotor replacement and action plan was developed.

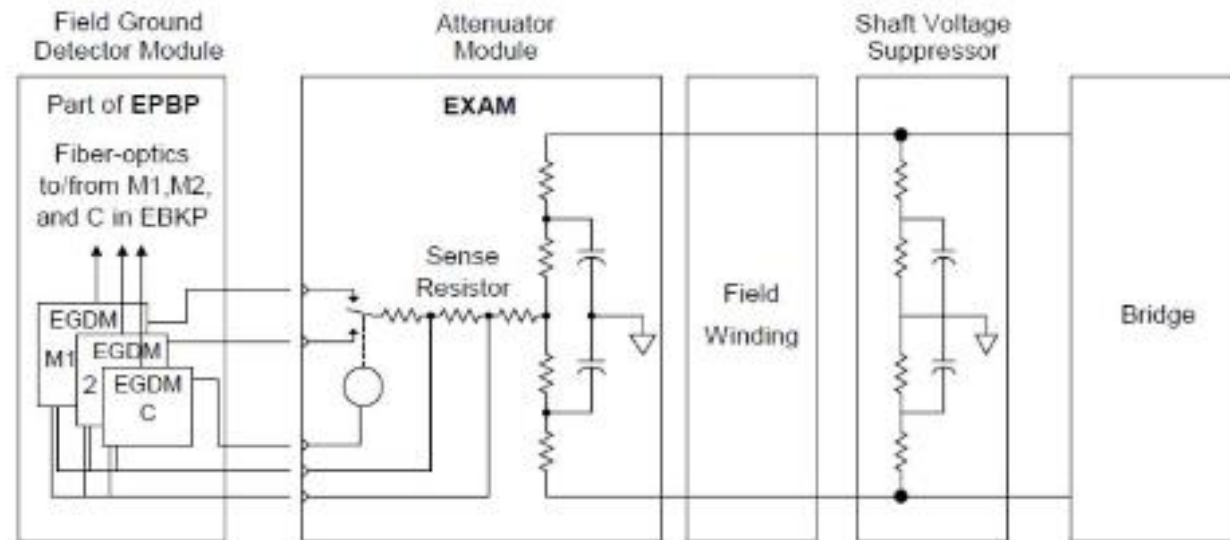
EGDM is installed in Excitation control panel and used to detect the insulation resistance between the Generator Field and ground.

Function can be tested using variable resistance and multimeter.

- Generator Rotor Field Ground Detection functionality test included in Yearly PM.
- It was found that field ground detection function was not working for this unit due to failure of control card (EXAM Card).
Card replaced and rectified.
- Study of adding the a diagnostic alarm in case of EGDM abnormality.

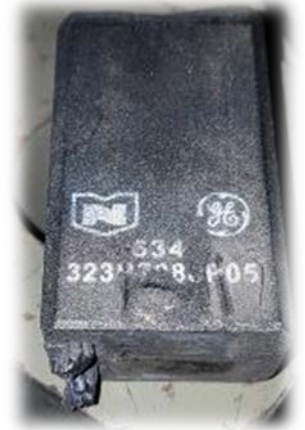
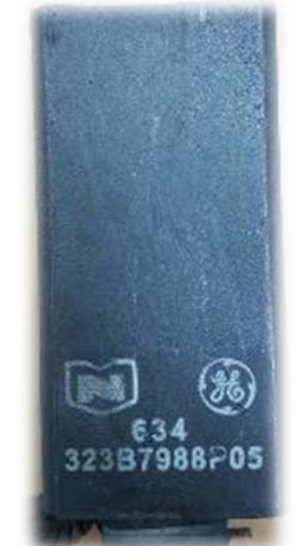
- Conducted Thorough inspection of all the units' Carbon Brush.
- Poor contact with slipring and current distribution is not proper.
- Overheated, Frayed and disconnected pigtails in some units.
- Most of the failure of a specific batch with OEM LOGO and Part Number

- Decided to purchase the carbon brushes directly in co-ordination with the manufacturer.

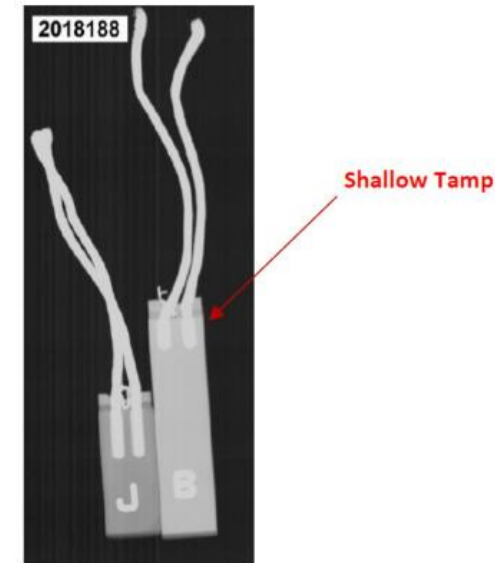
- Material Analysis performed and found suspected batch does not match quality requirement and considered as duped.

Properties	GRADE 634	QCCPP Brushes
Transverse Strength	750 PSI	1401 PSI
Pull Strength	>150 lbs	54 lbs
Specific resistance	0.001 ohm-inch	0.003 ohm-inch
Density	1.28 g/cm ³	1.67 g/cm ³
Contact Drop	1.7 mv/a	6.46 mv/a
Ash Contact	< 3.0 %	7.4 %
