# **Managing the Maintenance of the Runway at Baghdad International Airport**

# Problem statement

- 1- The surface of the runway 33R-15L of Baghdad international airport is badly covered with aeroplanes tyre rubber.
- 2- Such accumulation of rubber could impart the safety of landing at various environment conditions.
- 3-The international flight companies had claimed that the rough surface of the runway caused damage to their aeroplanes tyres and ask for an assessment to evaluate and suggestion for remedy.

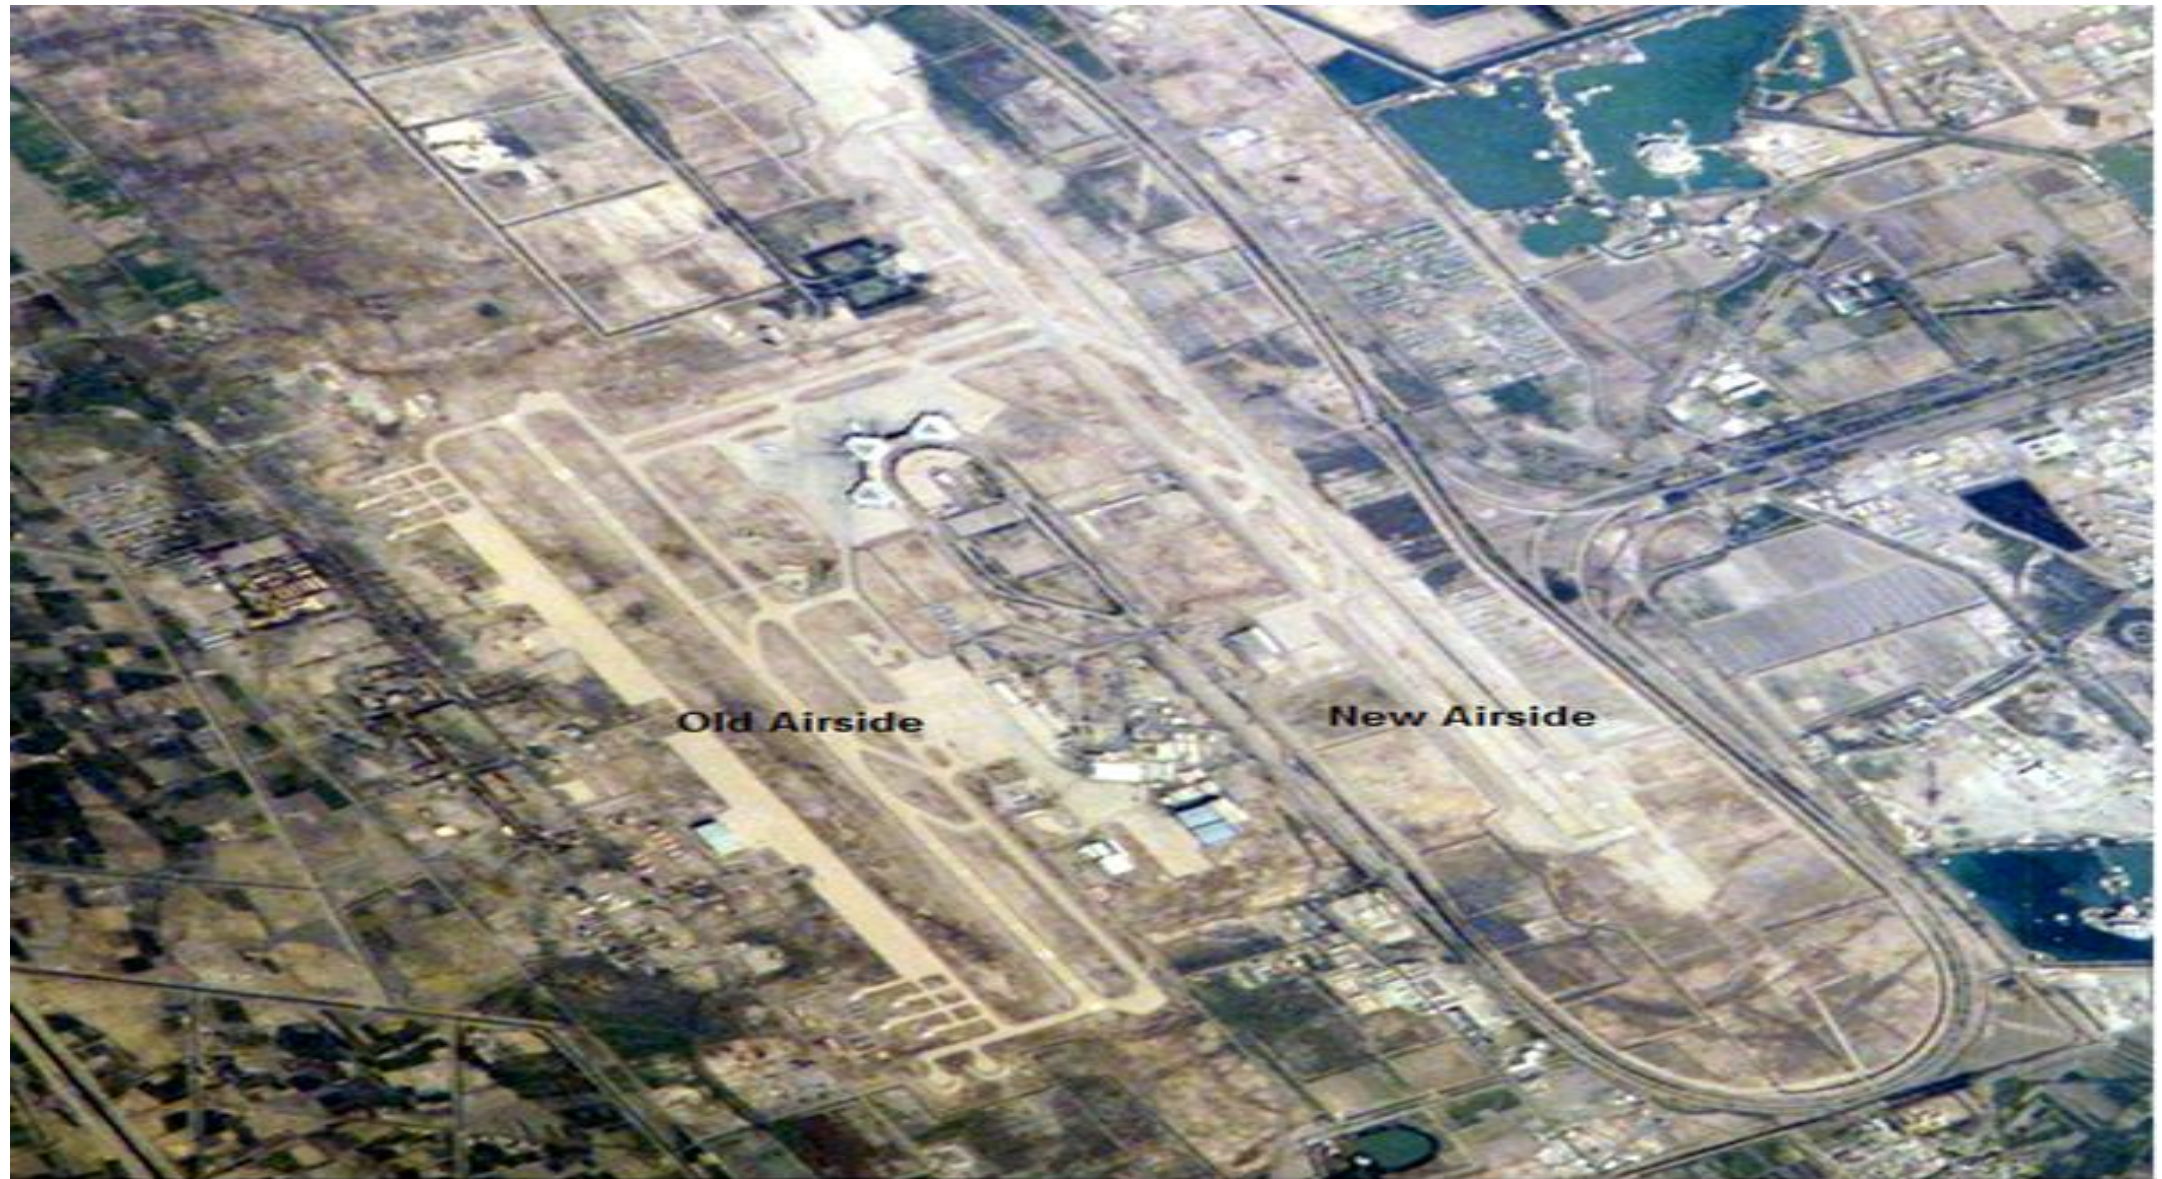
- **The new airside of Baghdad international airport had a runway of 4000 meters length and 45 meter width.**
- **It was constructed and came under service in 1982. Since 2010, the runway has seen increasing levels of commercial operations since it is supported with airfield lighting.**

- **The runway consists of concrete pavement constructed in 12 panels of 5x4 meters size in the cross section direction, both contraction and expansion joints have been implemented.**
- **At the touchdown zone, the pavement surface was badly covered with rubber to a width of 8 panels in the cross sectional direction.**
- **The joints exhibit loss of sealant materials or need top up of the sealant.**

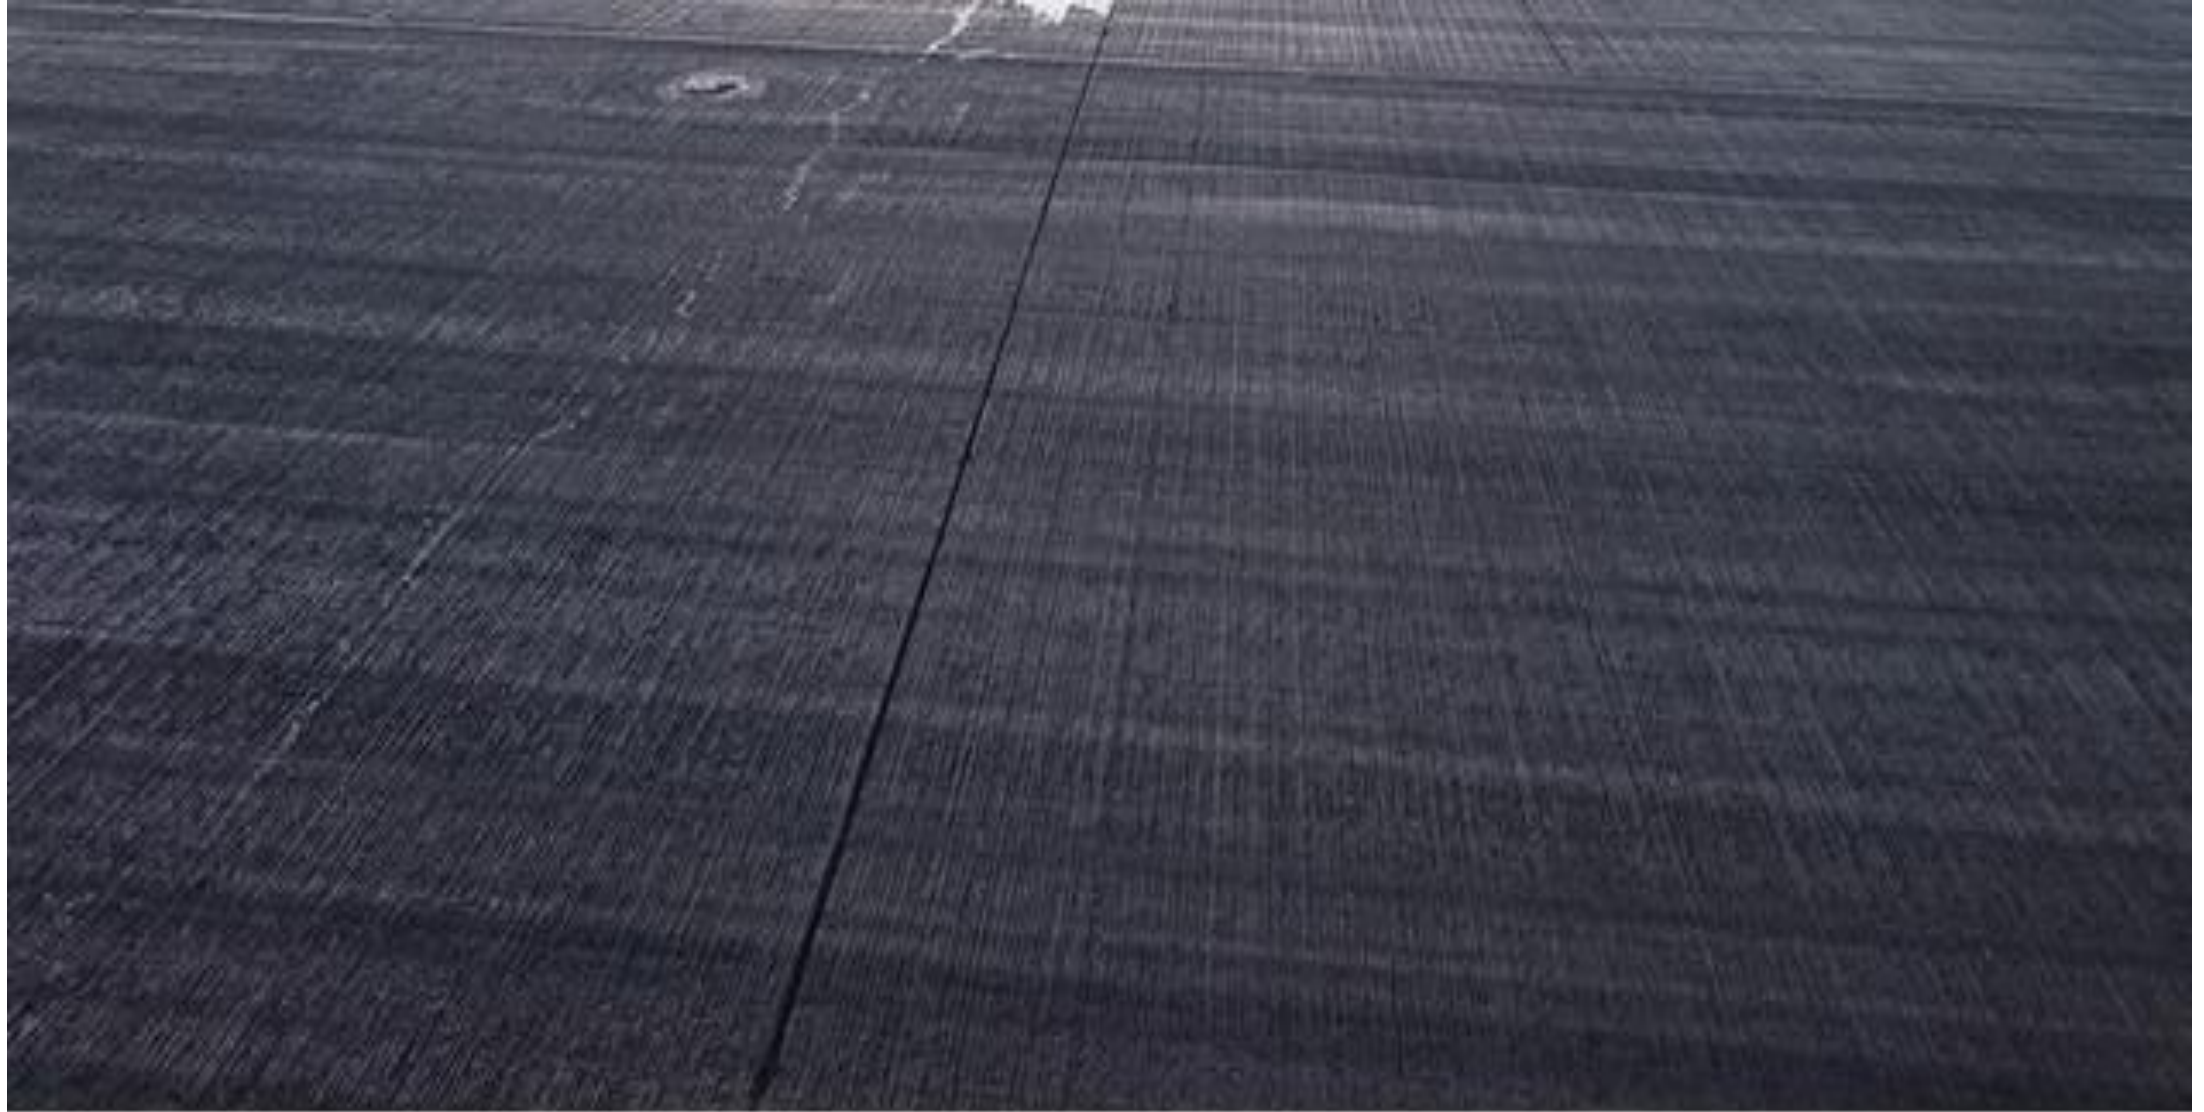
- **1- The airport site was visually investigated, the walk through technique was implemented starting from the threshold and along the touchdown zone to the centre of the runway from both directions (i.e. R and L).**

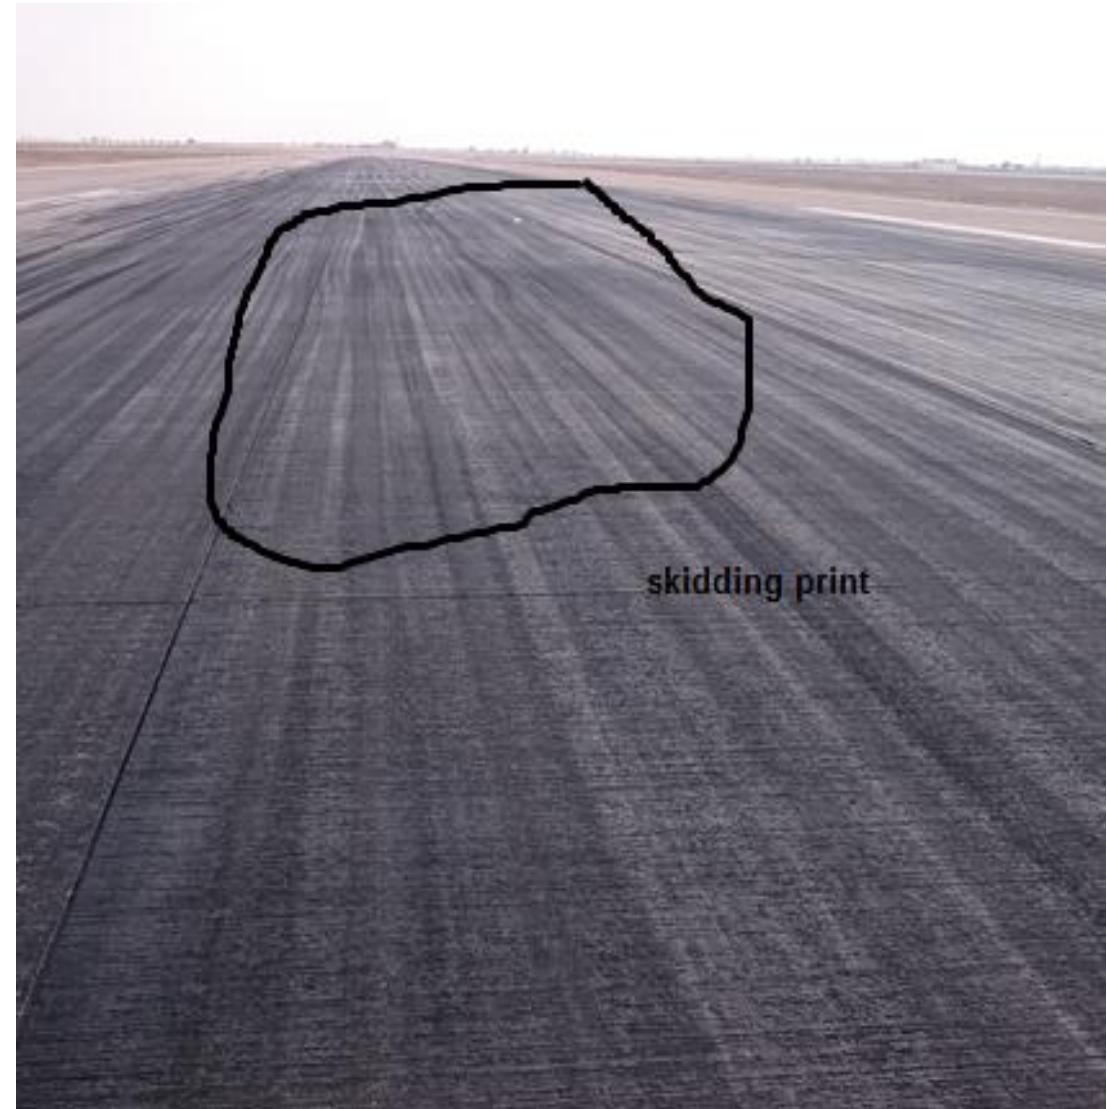
# Skidding prints at the start of touchdown zone

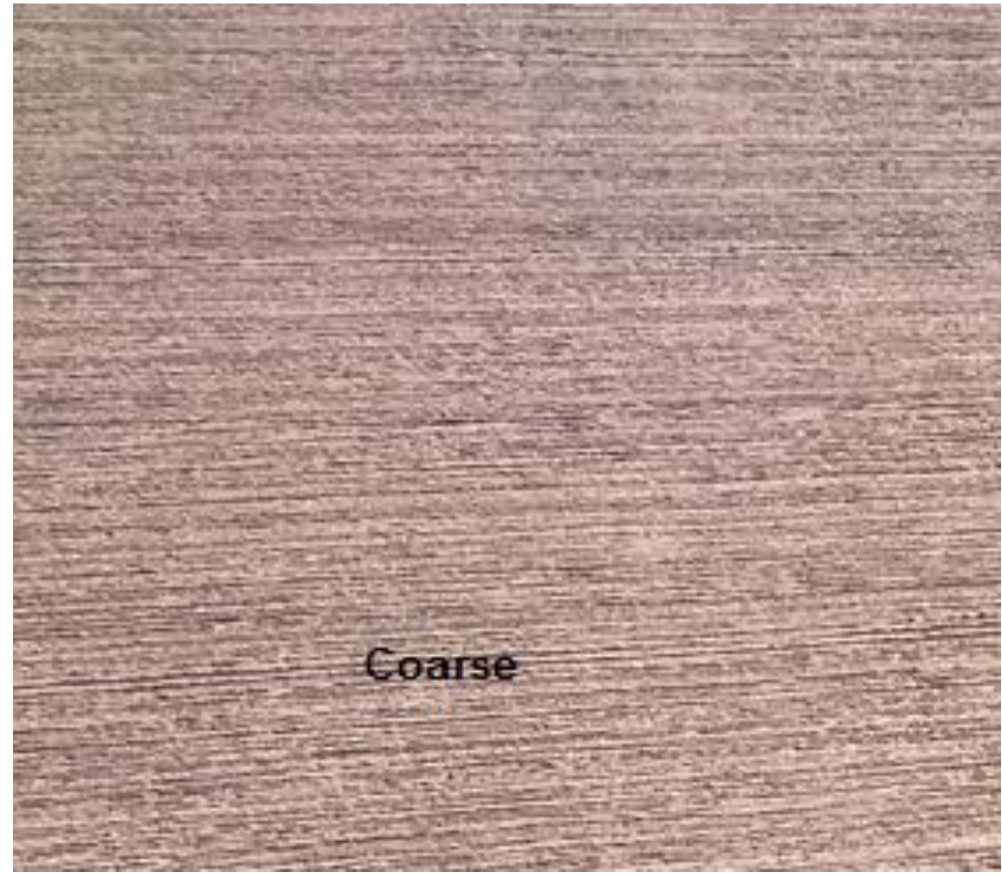
# Pavement texture quality varies from Coarse to medium

- **1- Mean texture depth MTD for all of the tested sections exceeds the minimum requirement of 1 mm as recommended by ICAO.**
- **2- Mean texture depth MTD should be maintained within a reasonable range of (1-2.5 mm), section with coarser texture should be subjected to grinding process so that the pavement exhibit a positive impact on tyre rubber wear.**

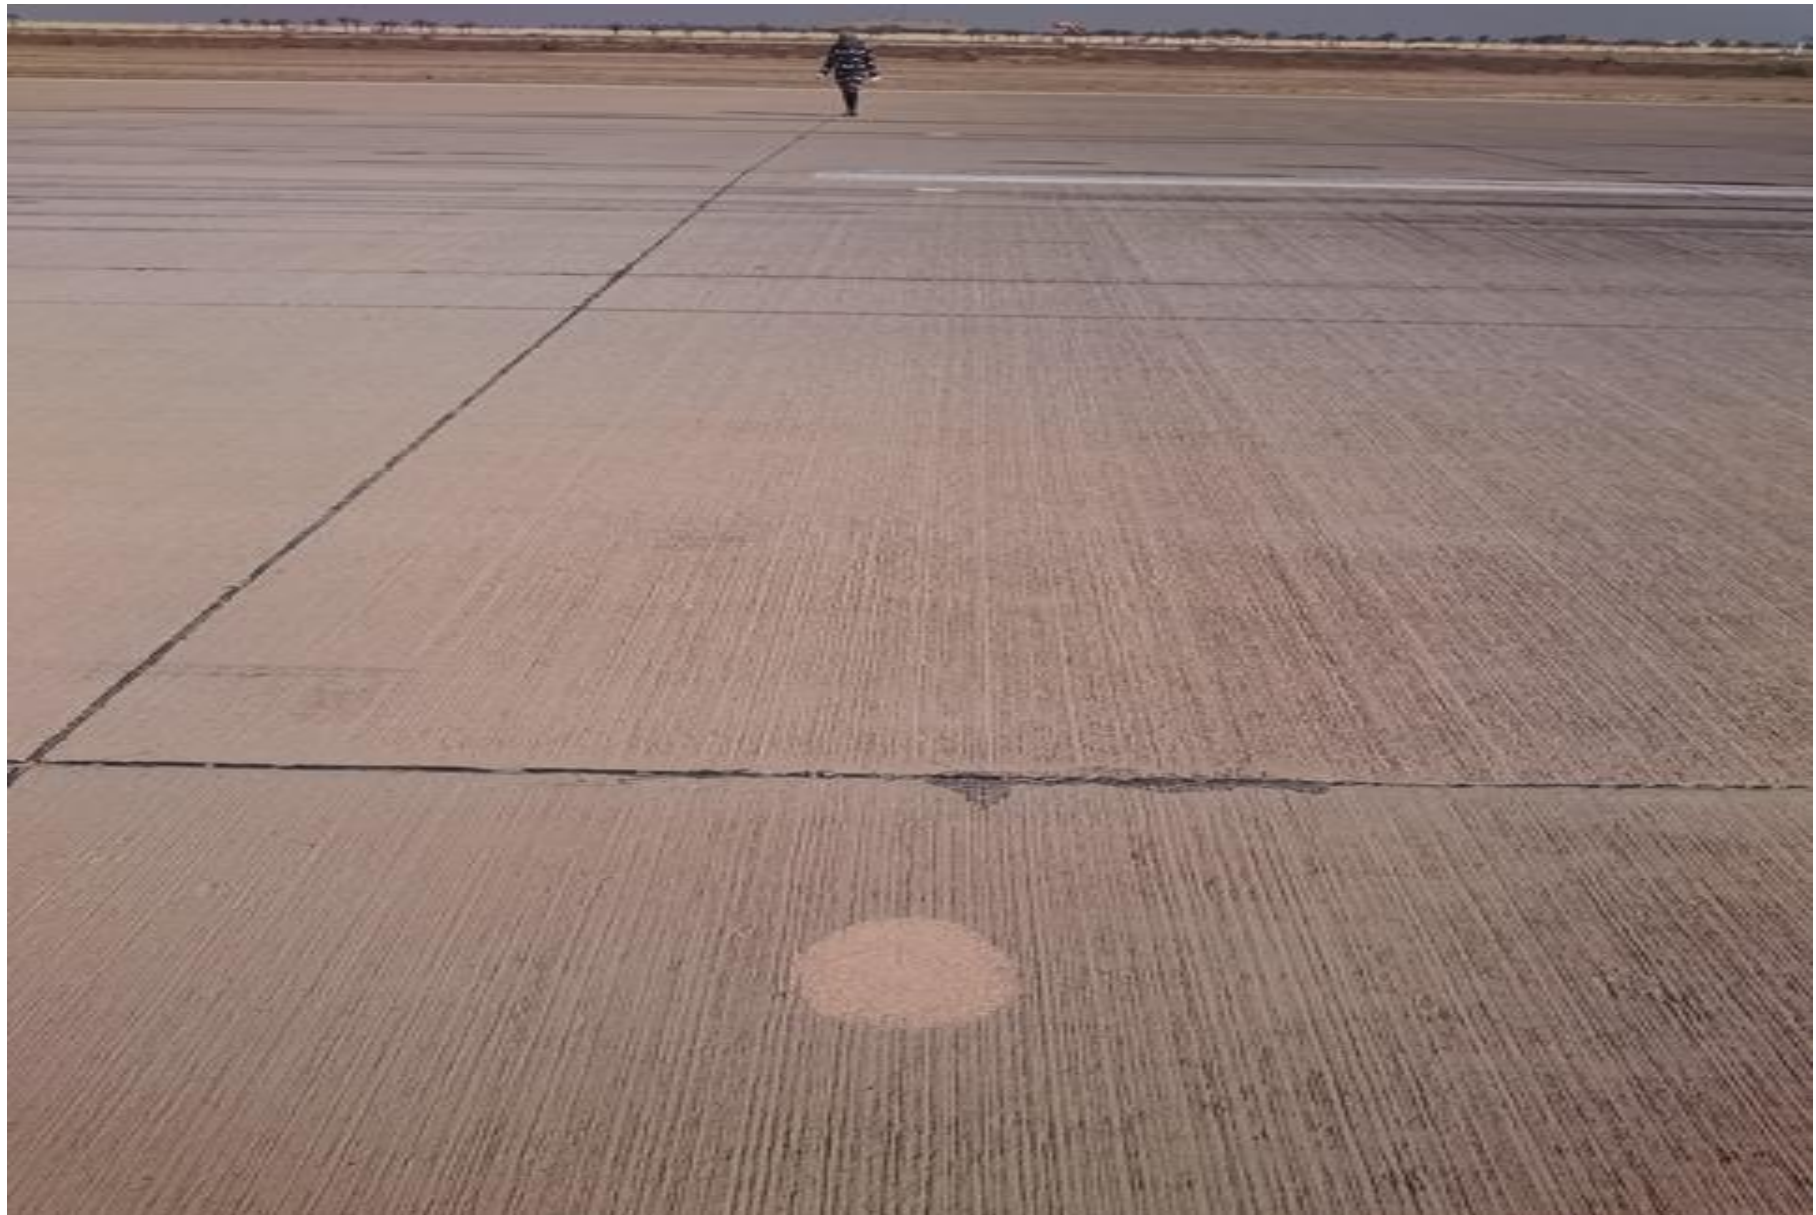
- **2- Staggered technique for the selection of testing location was implemented along each section so that for the adjacent panels one panel was tested while the second panel was left for that section, the next section will experience the testing of the panels opposite to those tested in the previous section.**

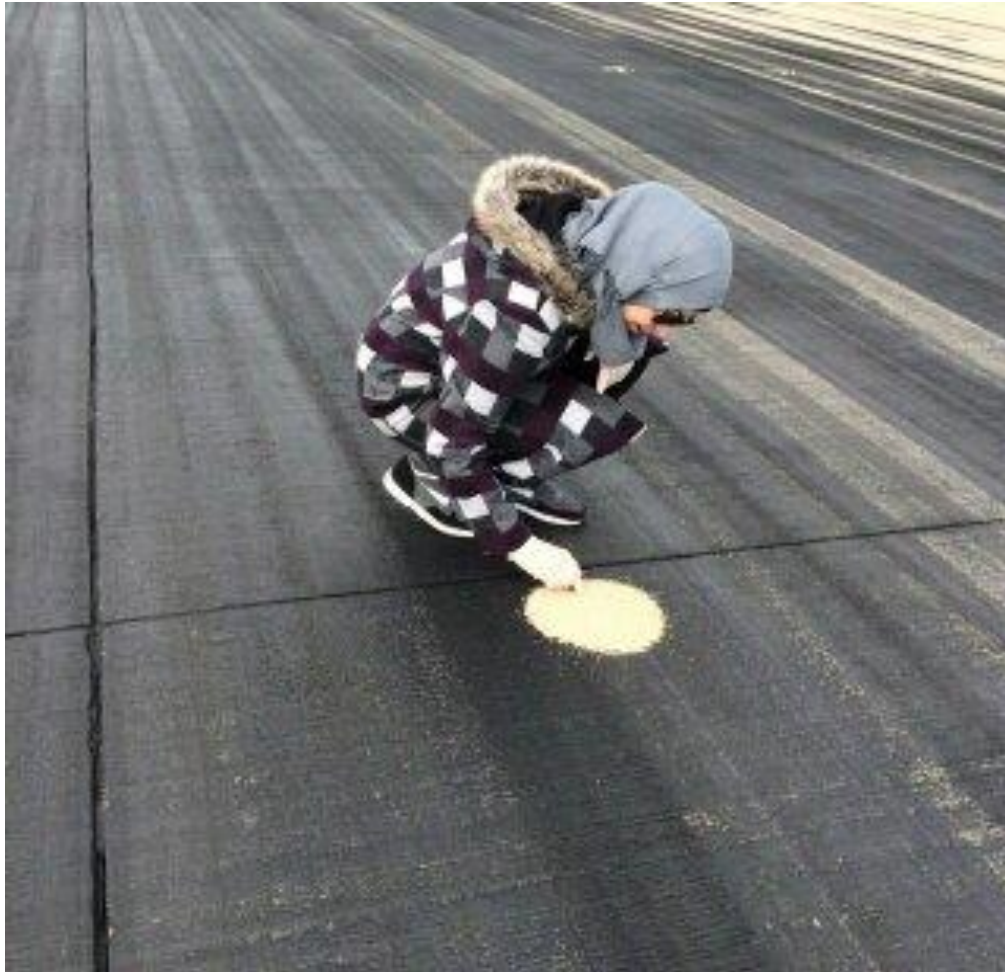
**3- Macrotexture assessment using sand patch method as per ASTM procedure. A total of 200 sand patches have been implemented to cover the assessment requirements.**

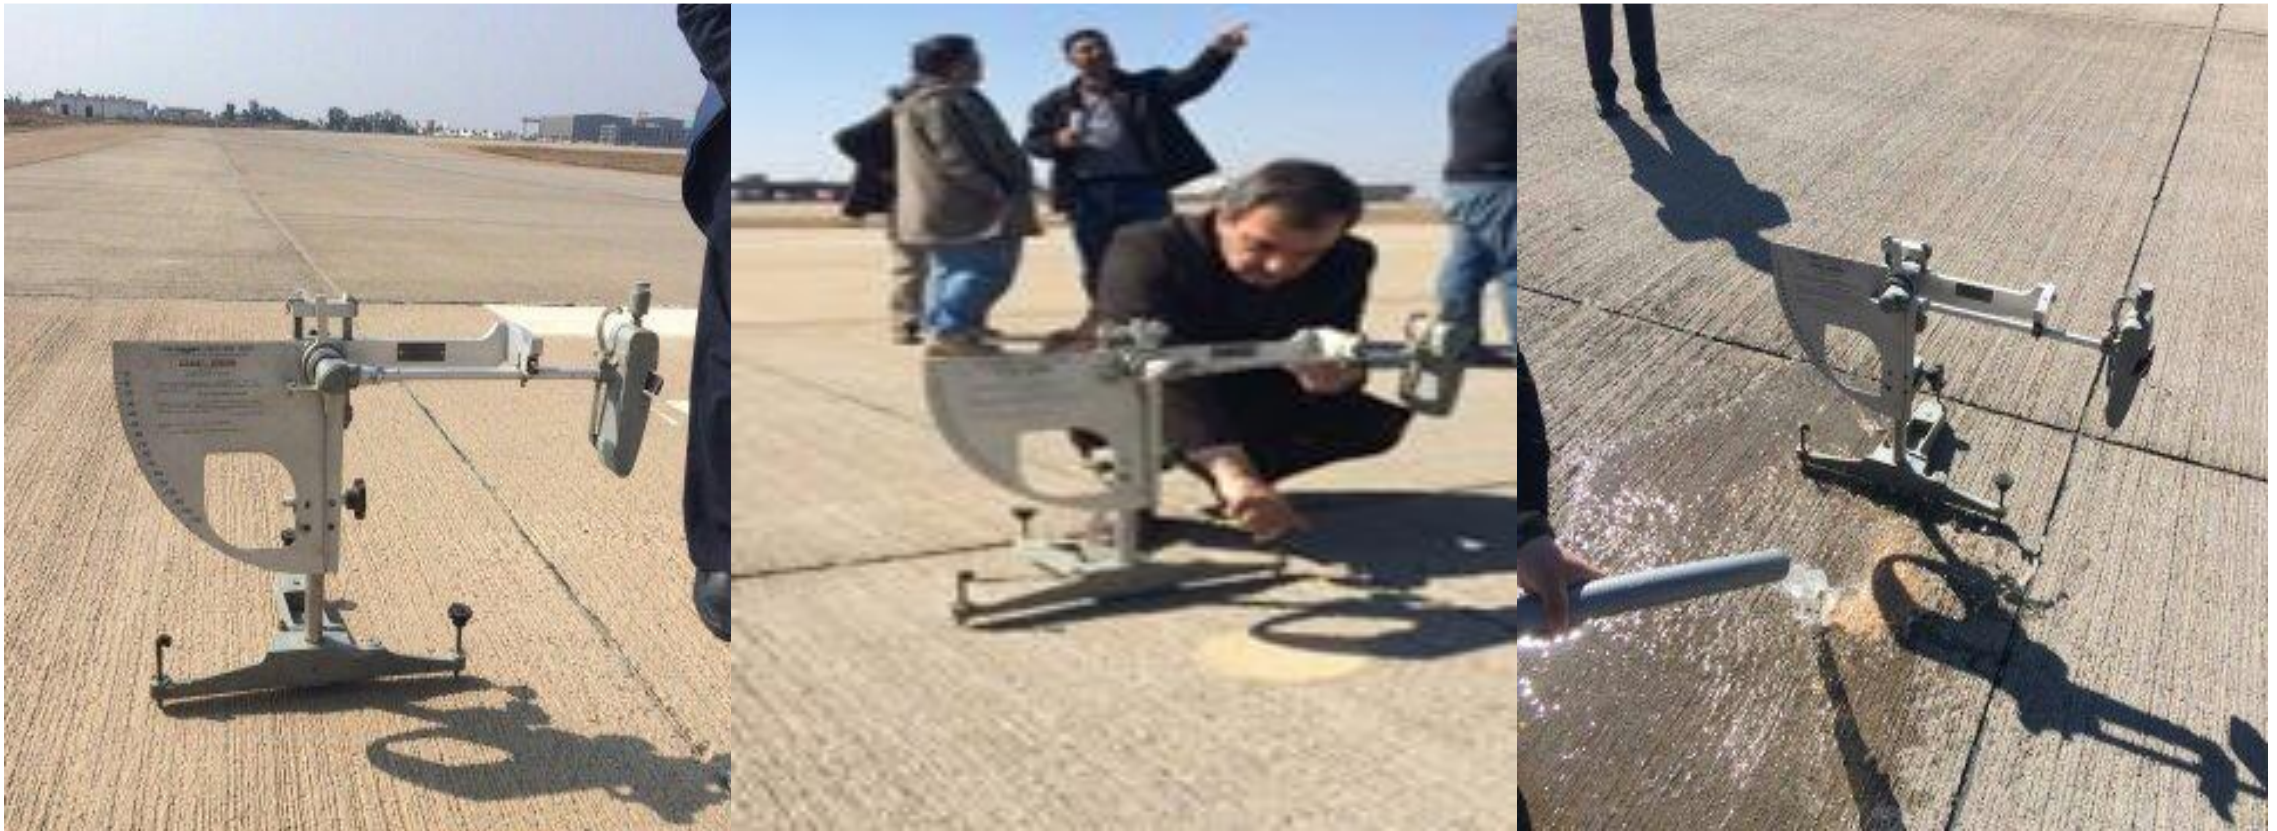
**4- Microtexture assessment using British pendulum tester (BPN) according to ASTM. A total of 200 test locations have been carefully selected at the same pre tested locations for macrotexture representing different concrete surface texture condition.**

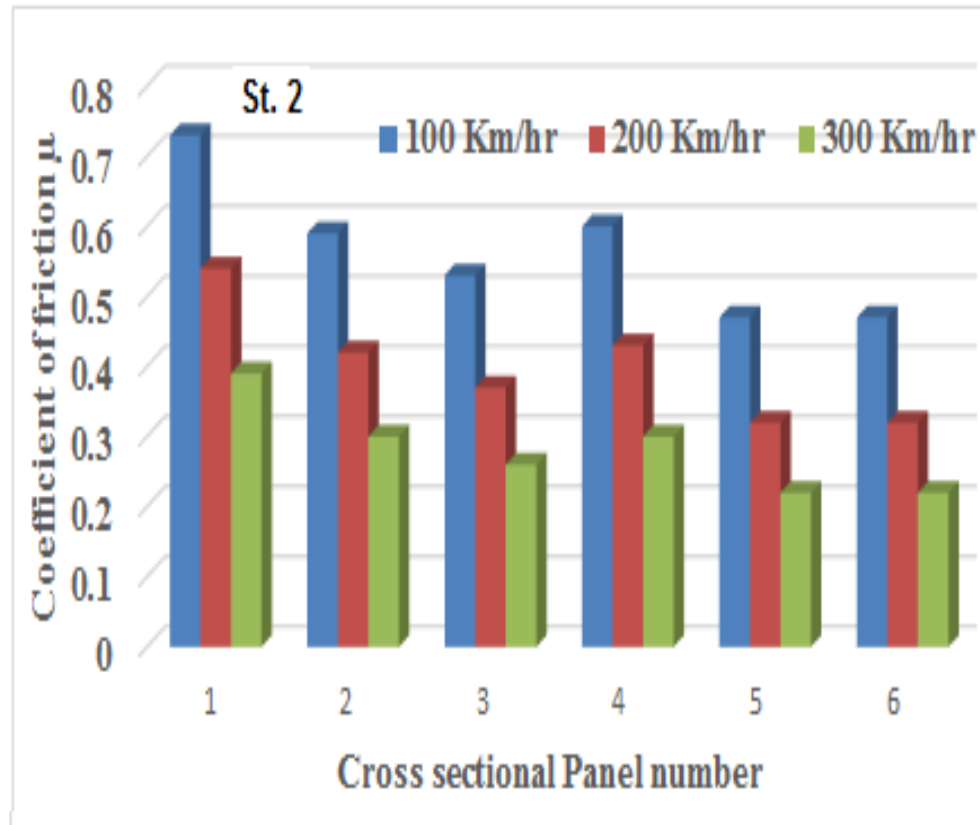
# Typical Variations in the friction property at threshold zone.

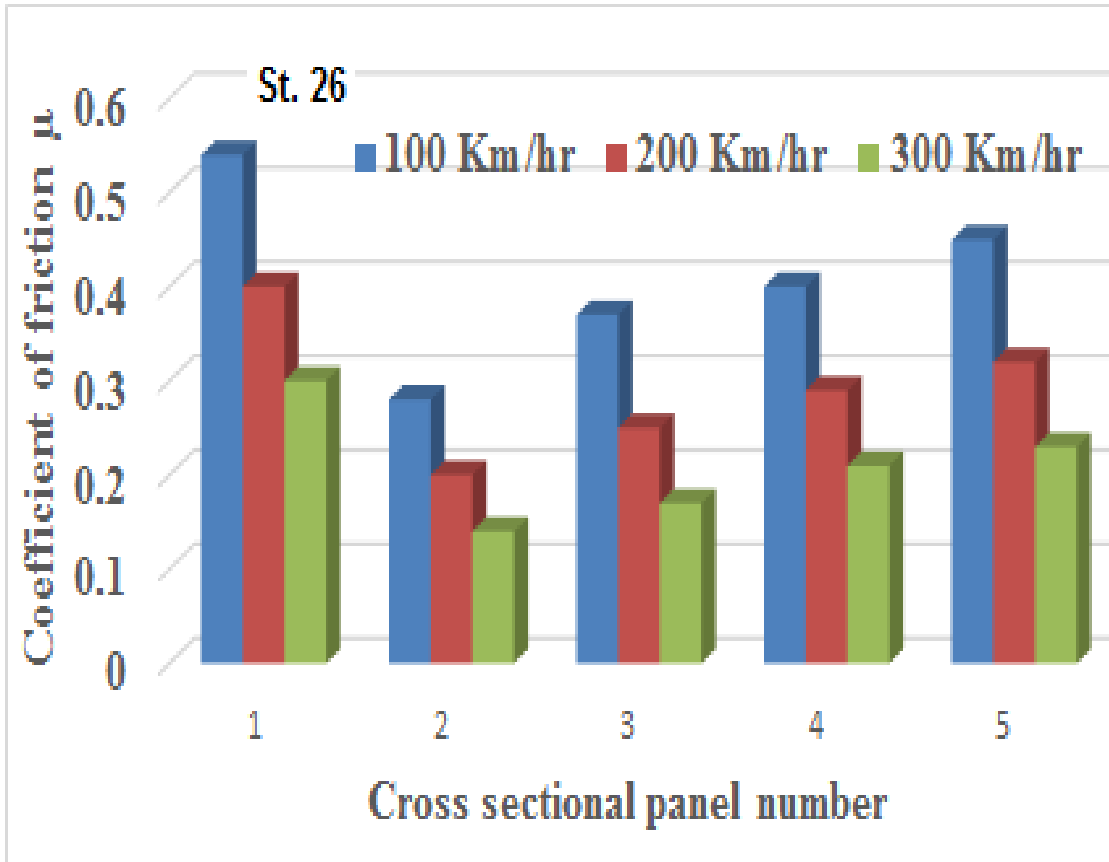
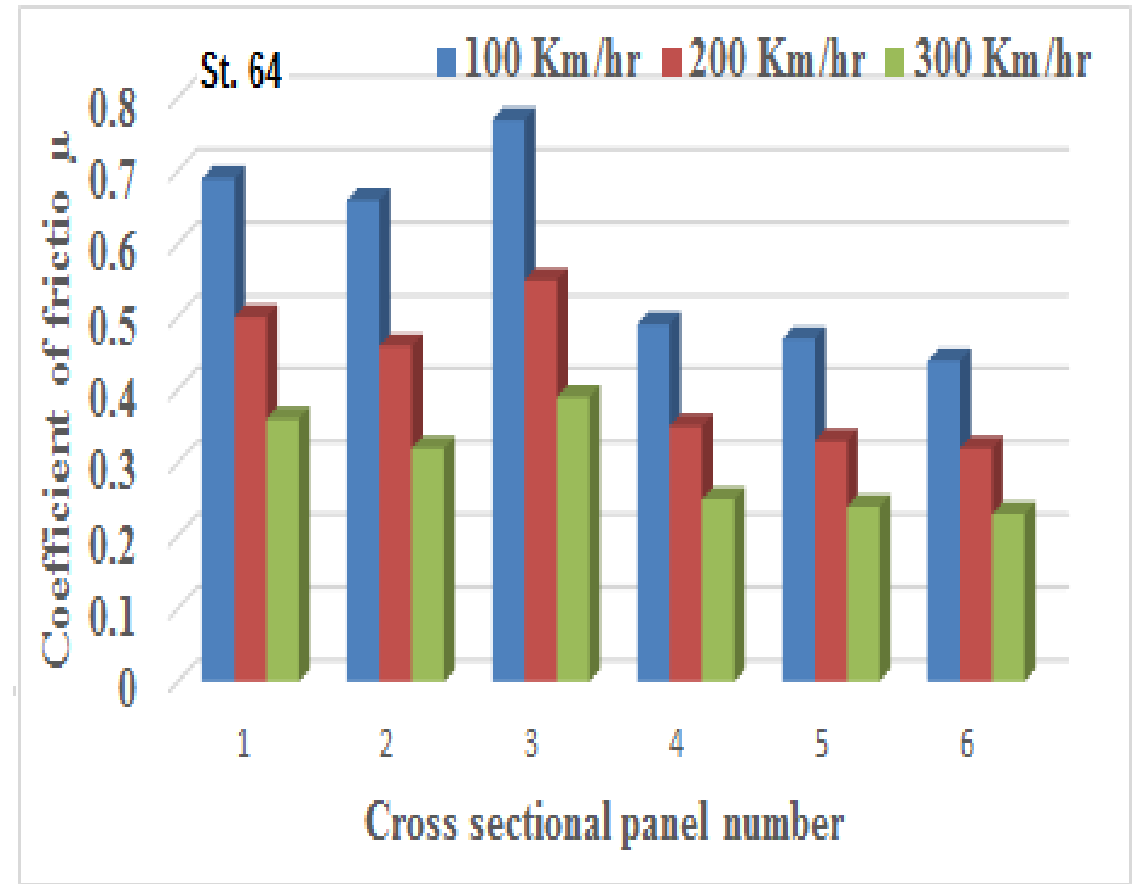
# Typical Variations in the friction property at the start of the touchdown zone.

- **6- The rubber accumulation at the touchdown zone could be considered as variable between (medium to dense) to (very dense) according to ICAO definition.**
- **As recommended by ICAO, the average surface texture depth should not be less than 1.0 mm.**
- **The minimum acceptable British Pendulum number (BPN) is 55%.**

- 3- The coefficient of friction  $\mu$  at the touchdown zone for wet pavement is variable between (0.40-0.19) which is considered risky and needs to be reserved by rubber removal operation.

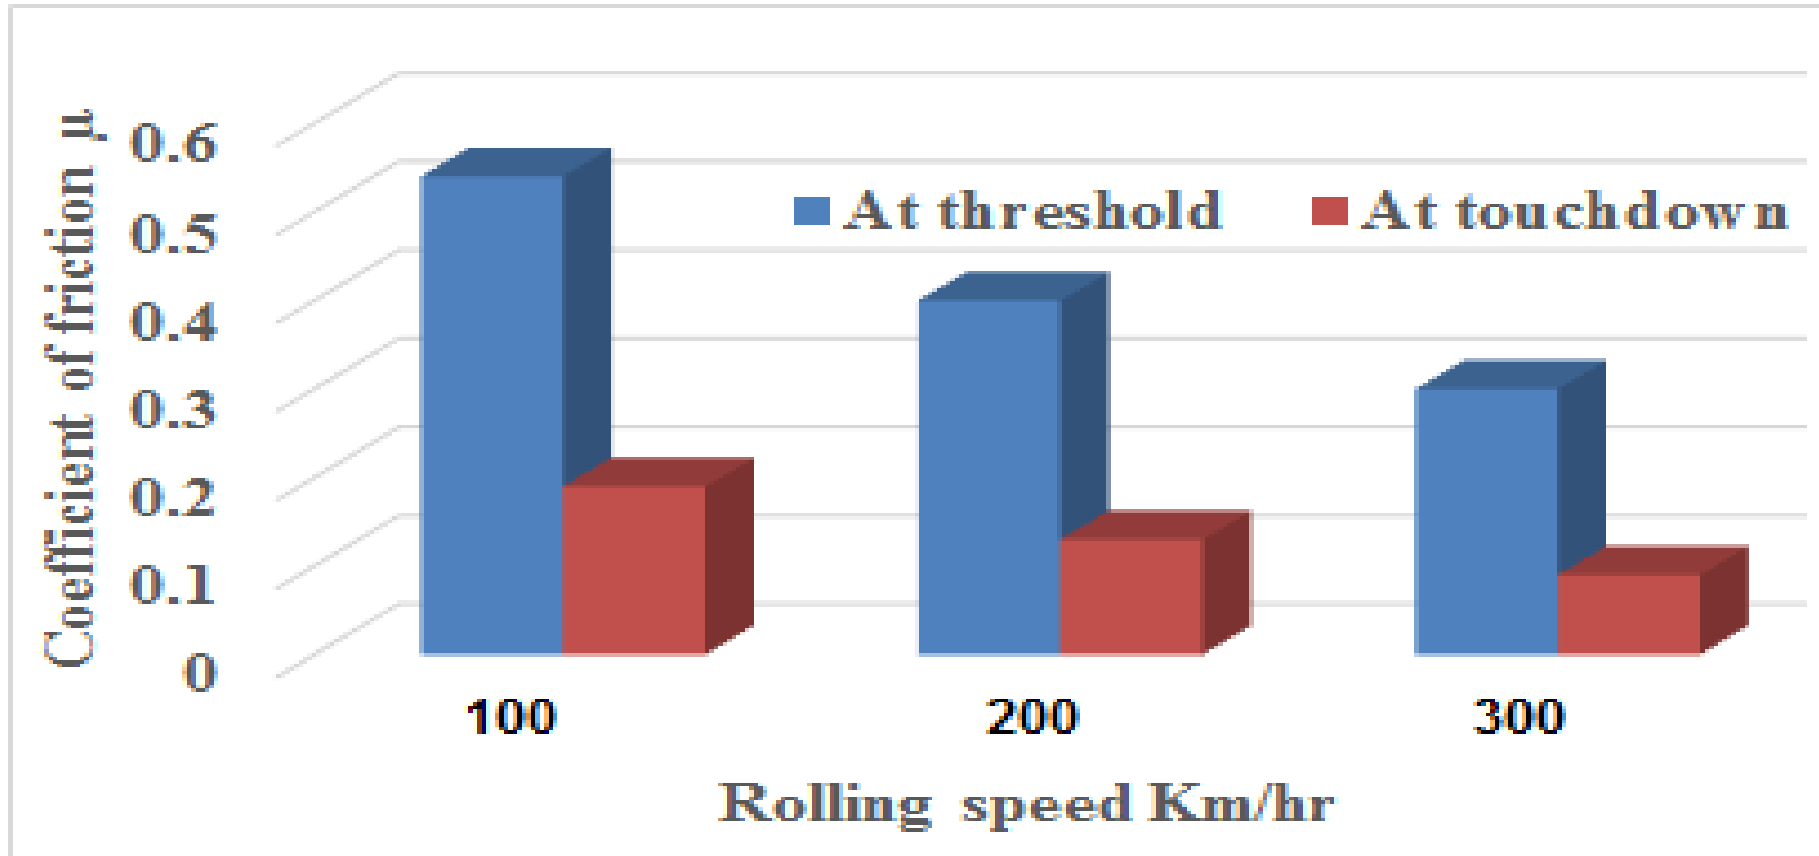
# Variation of friction with rolling speed

- 4- The coefficient of friction decreases by 20% when the rolling speed is doubled.
